## **YASS VALLEY COUNCIL**

### **ARBORIST REPORT – 110 Rossi Street YASS**

23 May 2025

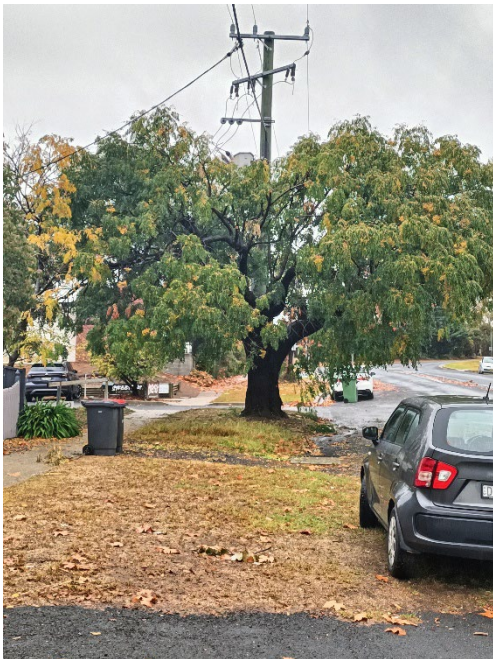
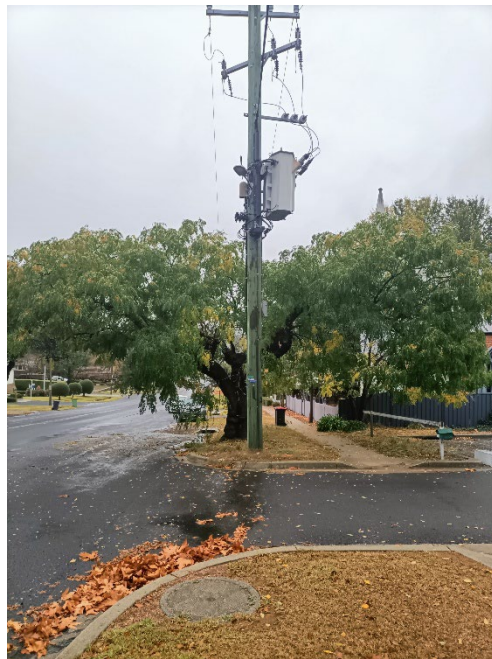
Tree has experienced continual pruning to remove the tree canopy from adjacent to the power line conductors. The tree is adjacent to the power pole (3m).

The tree is mature with overextended branch structure.

The elongated and overextended main branches of this tree and the potential for splitting at the attachments on the trunk base contribute to the MODERATE risk assessment for this tree.

The likelihood of failure is probable. Recommendation is for removal at the earliest opportunity and replacement with a tree species appropriate for the location and powerline constraints.
